**Flood Control Project Maintenance
Levee Inspections**

Maintenance Issue Types Only, Levee Inspection Report By Mile - Spring 2017

Reclamation District No. 0524 Middle Roberts Island

Waterway	Bank	Unit Miles	Inspection Start/End	Inspector
Unit No. 01 San Joaquin River	Left	6.20	04/04/2017 04/05/2017	Richard Willoughby

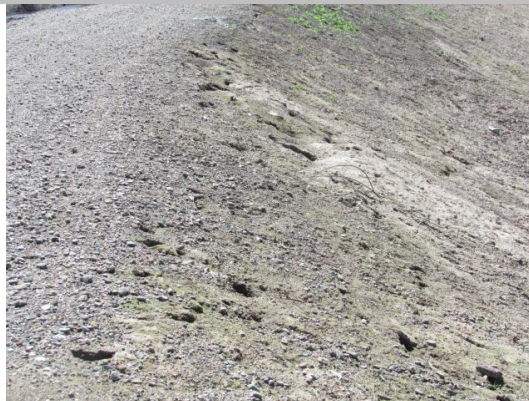
Photo 2 of 2 : SP_2017_RD0524_107_69_20170316_00114.jpg

LM Start	5.64	Rating **	U	Issue No.	69 (cont)	
LM End	5.80	Issue Type +	Ma	Location *	LS	
Category	Earthen Levee			GPS Latitude/Longitude		
				Start		End
Item	Animal Control			37.877298 °		37.875073 °
				-121.332343 °		-121.333168 °
DWR ID	DWR_RD0524_01_s_2012_69					
Comment Code						
A3 : No rodents visible, but rodent burrows visible; need to backfill and compact or grout burrows.						
Inspector Comment						
District has grouted rodent holes. But rodents have re-appeared.

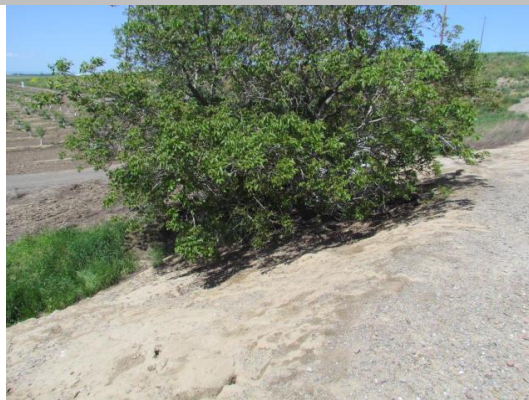
Photo 1 of 1 : SP_2017_RD0524_107_117_20170316_00176.jpg

LM Start	5.64	Rating **	U	Issue No.	117
LM End	5.64	Issue Type +	Ma	Location *	LS
Category	Earthen Levee			GPS Latitude/Longitude	
				Start	End
Item	Trim / Thin Trees			37.877272°	37.877272°
				-121.332400°	-121.332400°
DWR ID	DWR_RD0524_01_f_2013_117				
Comment Code					
T1 : Trim trees to at least five feet above ground level.					
Inspector Comment

Looking northwest at untrimmed tree on landward slope.

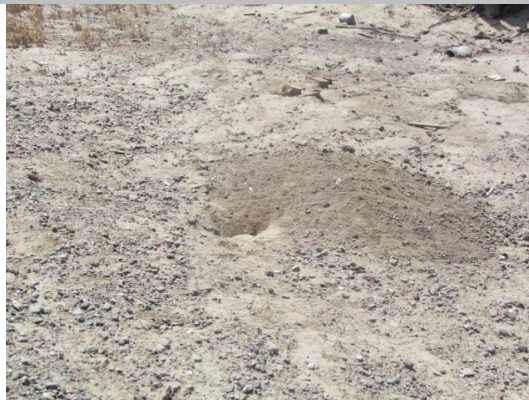
Photo 1 of 2 : SP_2017_RD0524_107_197_20170316_00228.jpg

LM Start	5.77	Rating **	M	Issue No.	197
LM End	5.79	Issue Type +	Ma	Location *	LS
Category	Earthen Levee			GPS Latitude/Longitude	
				Start	End
Item	Animal Control			37.875545 °	37.875310 °
				-121.332952 °	-121.333065 °
DWR ID	DWR_RD0524_01_s_2015_197				
Comment Code					
A1 : Exterminate rodents and backfill and compact or grout burrows.					
Inspector Comment					
Several rodent holes on landward slope and levee crown.

Looking north at typical view of rodent holes on landward slope.

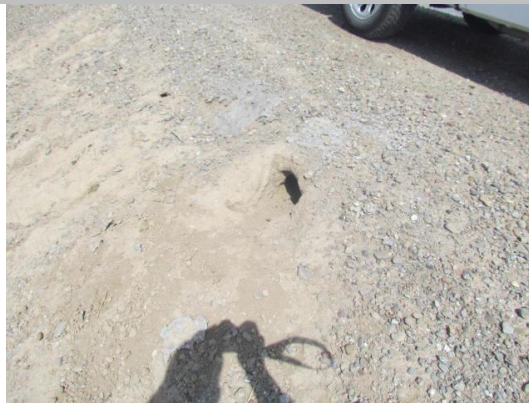
Photo 2 of 2 : SP_2017_RD0524_107_197_20170316_00229.jpg

LM Start	5.77	Rating **	M	Issue No.	197 (cont)
LM End	5.79	Issue Type +	Ma	Location *	LS
Category	Earthen Levee			GPS Latitude/Longitude	
				Start	End
Item	Animal Control			37.875545 °	37.875310 °
				-121.332952 °	-121.333065 °
DWR ID	DWR_RD0524_01_s_2015_197				
Comment Code					
A1 : Exterminate rodents and backfill and compact or grout burrows.					
Inspector Comment					
Several rodent holes on landward slope and levee crown.

Looking southwest at typical view of rodent hole at landward shoulder.

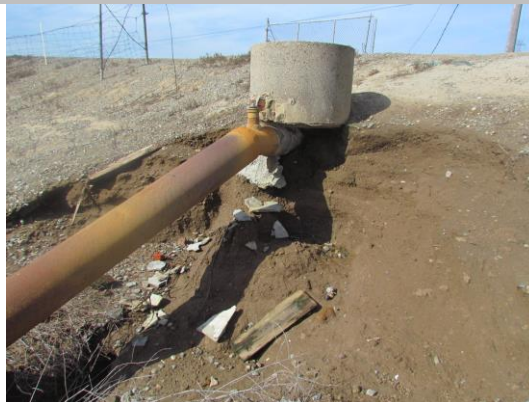
Photo 1 of 3 : SP_2017_RD0524_107_183_20170407_00398.jpg

LM Start	5.81	Rating **	U	Issue No.	183
LM End	5.81	Issue Type +	Ma	Location *	WS
Category	Earthen Levee			GPS Latitude/Longitude	
				Start	End
Item	Erosion / Bank Caving			37.874973 °	37.874973 °
				-121.333227 °	-121.333227 °
DWR ID	DWR_RD0524_01_s_2017_183				
Comment Code					
E2 : Schedule repair of erosion site prior to the next inspection.					
Inspector Comment					
Bank caving on waterside around pipe structure.

Looking west at erosion around pipe and on waterward slope.

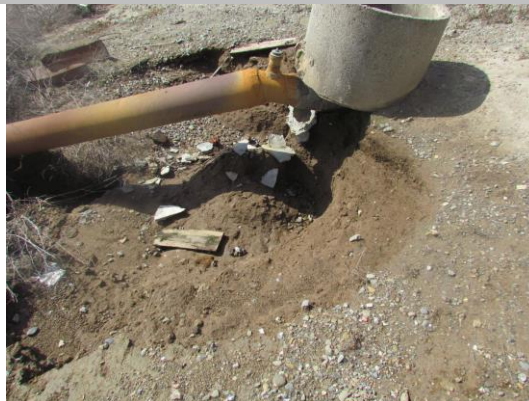
Photo 2 of 3 : SP_2017_RD0524_107_183_20170407_00397.jpg

LM Start	5.81	Rating **	U	Issue No.	183 (cont)	
LM End	5.81	Issue Type +	Ma	Location *	WS	
Category	Earthen Levee			GPS Latitude/Longitude		
				Start	End	
Item	Erosion / Bank Caving			37.874973 °	37.874973 °	
				-121.333227 °	-121.333227 °	
DWR ID	DWR_RD0524_01_s_2017_183					
Comment Code						
E2 : Schedule repair of erosion site prior to the next inspection.						
Inspector Comment						
Bank caving on waterside around pipe structure.

Looking south at erosion around pipe and on waterward slope.

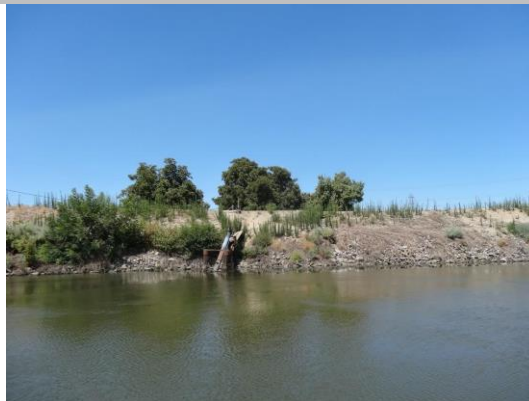
Photo 1 of 2 : SP_2017_RD0524_107_139_20170316_00194.jpg

LM Start	5.86	Rating **	U	Issue No.	139
LM End	5.86	Issue Type +	Ma	Location *	WS
Category	Supplemental			GPS Latitude/Longitude	
				Start	End
Item	DWR Erosion Survey			37.874370 °	37.874370 °
				-121.332850 °	-121.332850 °
DWR ID	DWR_RD0524_01_s_2017_139				
Comment Code					
Inspector Comment					
07/25/2016: No significant change observed.					
06/24/2015: No significant change observed.					
06/19/2014: No significant change observed.					
08/13/2013: No significant change observed.					
08/07/2012: The erosion is near a water-intake structure. Pipe leakage likely caused the erosion. [2016 Site ID:RD0524U01RM46.39]

Close view of the erosion and the pipe on the site.

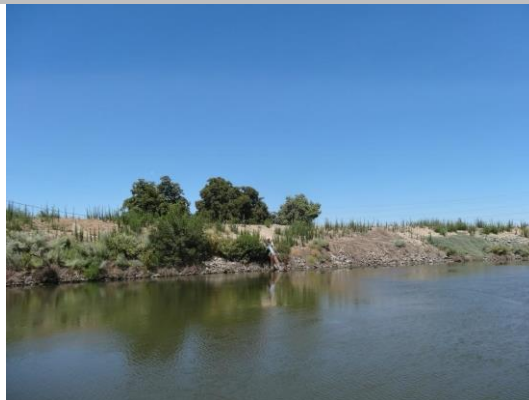
Photo 2 of 2 : SP_2017_RD0524_107_139_20170316_00195.jpg

LM Start	5.86	Rating **	U	Issue No.	139 (cont)
LM End	5.86	Issue Type +	Ma	Location *	WS

Upstream view of the erosion and vegetation at the site.

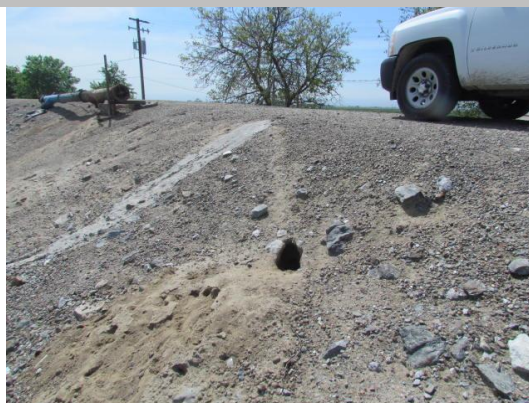
Photo 2 of 2 : SP_2017_RD0524_107_75_20170316_00123.jpg

LM Start	5.86	Rating **	M	Issue No.	75 (cont)
LM End	5.88	Issue Type +	Ma	Location *	WS

Looking southwest at typical rodent holes on waterward slope.

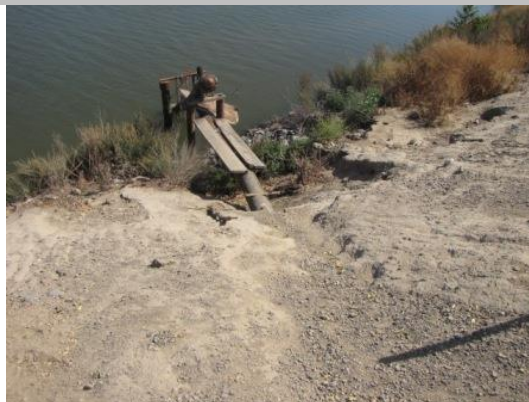
Photo 1 of 3 : SP_2017_RD0524_107_74_20170316_00119.jpg

LM Start	5.86	Rating **	U	Issue No.	74
LM End	5.87	Issue Type +	Ma	Location *	WS
Category	Earthen Levee			GPS Latitude/Longitude	
				Start	End
Item	Erosion / Bank Caving			37.874240 °	37.874165 °
				-121.333185 °	-121.333155 °
DWR ID	DWR_RD0524_01_s_2012_74				
Comment Code					
E1 : Note and monitor erosion site.					
Inspector Comment					
Erosion on landward slope around intake pipe.

Looking southeast at erosion around pipe.

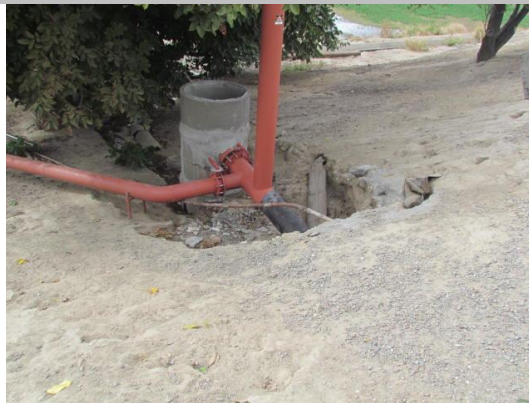
Photo 2 of 3 : SP_2017_RD0524_107_74_20170316_00120.jpg

LM Start	5.86	Rating **	U	Issue No.	74 (cont)
LM End	5.87	Issue Type +	Ma	Location *	WS
Category	Earthen Levee			GPS Latitude/Longitude	
				Start	End
Item	Erosion / Bank Caving			37.874240 °	37.874165 °
				-121.333185 °	-121.333155 °
DWR ID	DWR_RD0524_01_s_2012_74				
Comment Code					
E1 : Note and monitor erosion site.					
Inspector Comment					
Erosion on landward slope around intake pipe.

Looking west at erosion around intake pipe on landward slope.

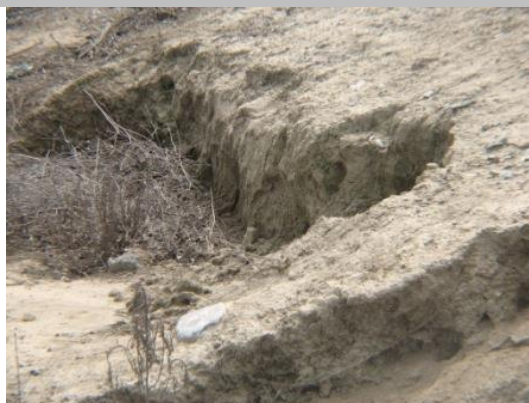
Photo 3 of 3 : SP_2017_RD0524_107_74_20170316_00121.jpg

LM Start	5.86	Rating **	U	Issue No.	74 (cont)
LM End	5.87	Issue Type +	Ma	Location *	WS

Erosion at waterward toe and around irrigation pipe at LM 5.92

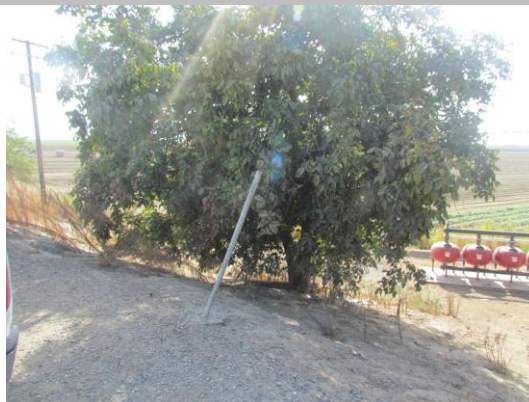
Photo 1 of 1 : SP_2017_RD0524_107_217_20170316_00254.jpg

LM Start	5.87	Rating **	U	Issue No.	217
LM End	5.87	Issue Type +	Ma	Location *	LS
Category	Earthen Levee			GPS Latitude/Longitude	
				Start	End
Item	Trim / Thin Trees			37.874090 °	37.874090 °
				-121.333162 °	-121.333162 °
DWR ID	DWR_RD0524_01_s_2016_217				
Comment Code					
T1 : Trim trees to at least five feet above ground level.					
Inspector Comment					
Untrimmed walnut tree on landward slope.

Looking west at walnut tree on landward slope.

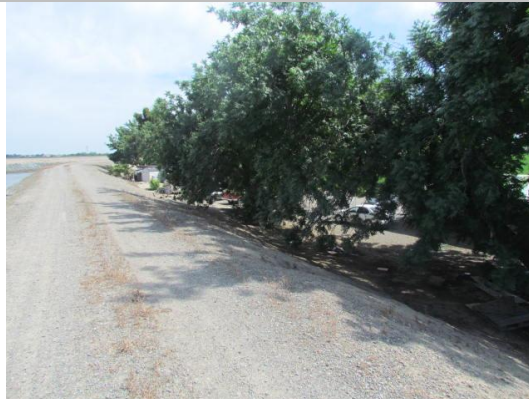
Photo 1 of 1 : SP_2017_RD0524_107_120_20170316_00182.jpg

LM Start	5.96	Rating **	U	Issue No.	120
LM End	5.96	Issue Type +	Ma	Location *	LS
Category	Earthen Levee			GPS Latitude/Longitude	
				Start	End
Item	Trim / Thin Trees			37.873347 °	37.873347 °
				-121.332028 °	-121.332028 °
DWR ID	DWR_RD0524_01_s _ 2012_120				
Comment Code					
T1 : Trim trees to at least five feet above ground level.					
Inspector Comment

Looking south at untrimmed trees on landward slope and toe.

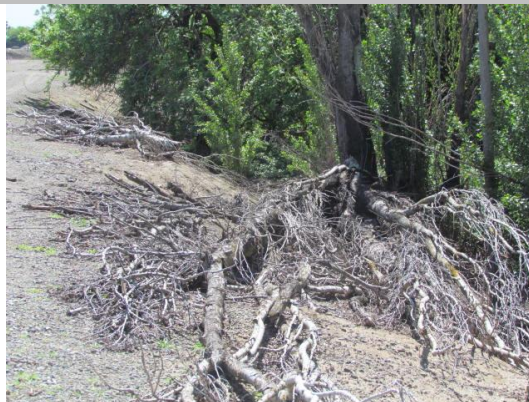
Photo 1 of 4 : SP_2017_RD0524_107_81_20170316_00131.jpg

LM Start	6.15	Rating **	U	Issue No.	81
LM End	6.15	Issue Type +	Ma	Location *	LS
Category	Earthen Levee			GPS Latitude/Longitude	
				Start	End
Item	Encroachments			37.871097 °	37.871097 °
				-121.330100 °	-121.330100 °
DWR ID	DWR_RD0524_01_s_2015_81				
Comment Code					
TR : Tree or limb					
Inspector Comment					
Large tree fallen across levee crown blocking access. Fallen tree branches and limbs left on landward slope.

Looking west at tree branches and limbs left on landward shoulder and slope. (Spring 2016)

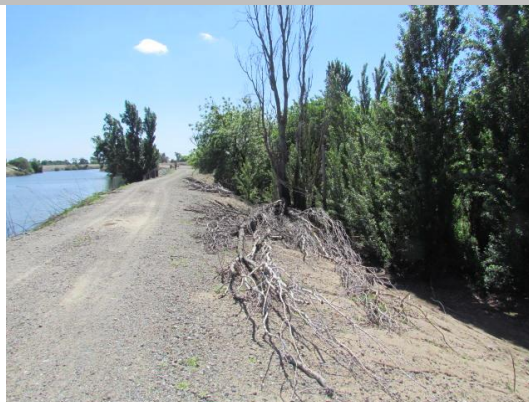
Photo 2 of 4 : SP_2017_RD0524_107_81_20170316_00132.jpg

LM Start	6.15	Rating **	U	Issue No.	81 (cont)
LM End	6.15	Issue Type +	Ma	Location *	LS

Looking south at tree branches and limbs left on landward shoulder and slope. (Spring 2016)
